# **EVALUATION OF RISK AND POSSIBLE MITIGATION SCHEMES FOR PREVIOUSLY UNIDENTIFIED HAZARDS**

William Linzey, Micah McCutchan, and Michael Traskos  
Lectromechanical Design Company

Richard Gilbrech, Ph.D.  
NASA Langley Research Center

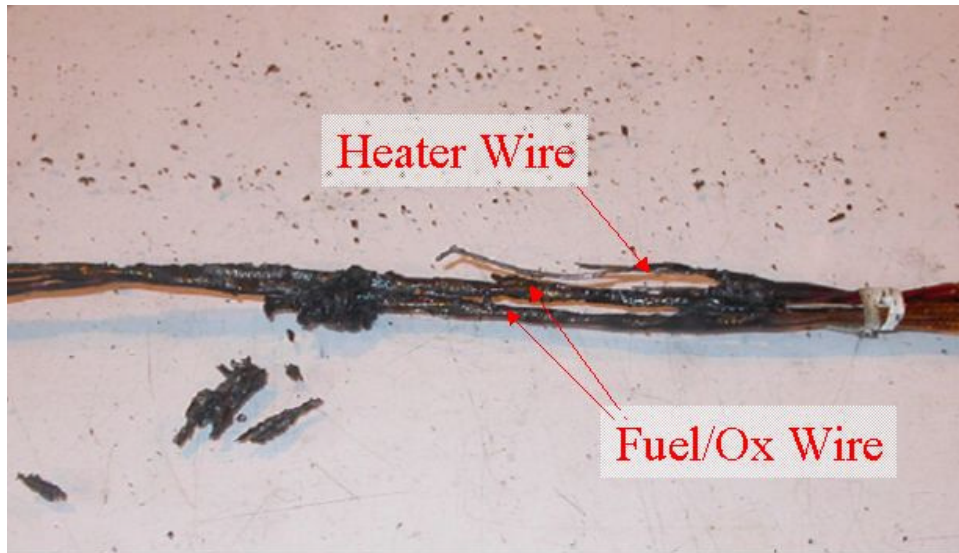
Figure 13 shows the post-test photo of Test Specimen 012. There has been damage to the fuel/ox wires and the shield has been exposed in several places. Because of the heat generated by arcing to the shield, it remains possible that the fuel/ox wire inside the shield may be heat damaged. However, as long as the shield is intact, it is impossible for voltage and current to be transferred from the arc to the inner wires.

**Figure 13. Post-test Photos of Test Specimen 012**

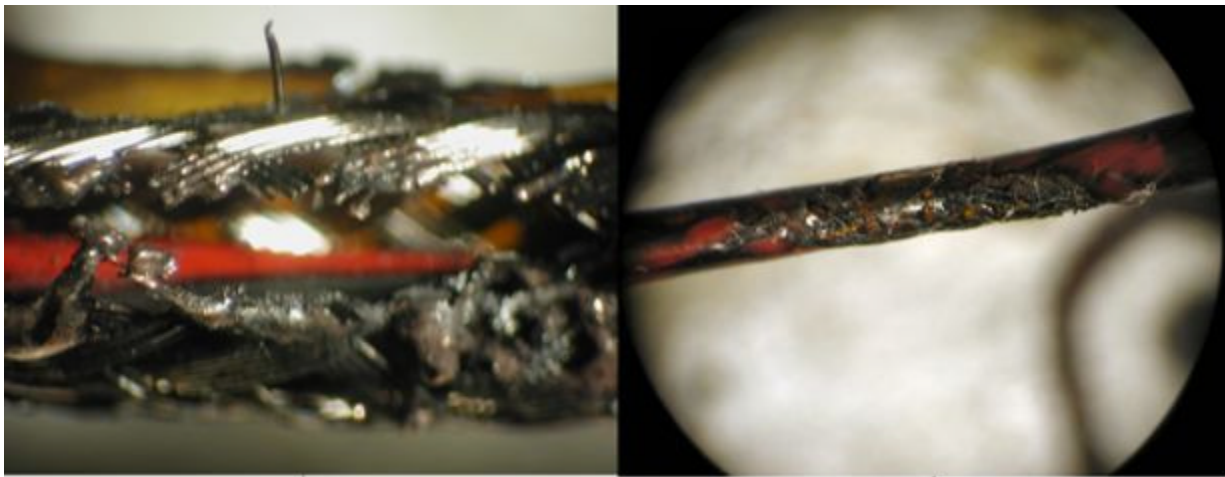
Figure 14a shows an example of a breach in the shield. Figure 14b shows damage to an inner fuel/ox wire at the point that it failed the wet DVW test. There is not an obvious breach exposing the conductor, but the insulation had been damage such that it could not prevent current conduction.

**Figure 14a. Close-up of Damaged Shield  
(Test Specimen 011)**

**14b. Photomicrograph of the Fuel/Ox Wire at the  
spot that it failed the wet DWV  
(Test Specimen 011)**
